Assessment of Pavement Performance Using the Pavement Condition Index (PCI): A Case Study of the Bengrah II Project in Palembang, Indonesia

Aldi Armahedi, Ely Mulyati*

Program Studi Teknik Sipil, Fakultas Sains dan Teknologi, Universitas Bina Darma, Jalan Jenderal Ahmad Yani No. 12, Plaju, Palembang 30264, Sumatera Selatan, Indonesia.

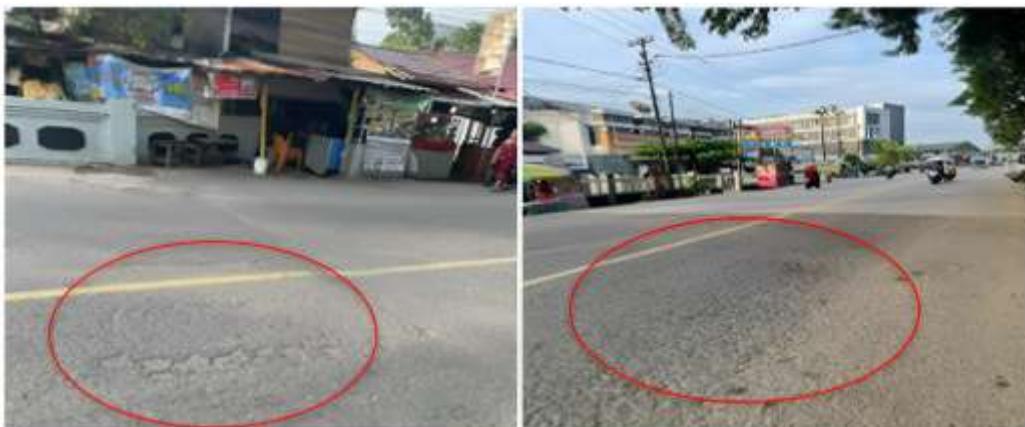
The physical condition of the pavement is shown in Figure 1 (view from the Public Works Office direction) and Figure 2 (view from the Port Hospital direction). These visual observations indicated that the pavement had been affected by repetitive axle loading, surface deformation, and particularly inadequate roadside drainage, which accelerated localized deterioration. Field inspections revealed that the drainage along the road shoulders was mostly shallow, partially clogged, and unevenly graded, preventing effective runoff during rainfall events. As a result, water stagnation frequently occurred at several low-lying points along the carriageway, especially near manholes and utility crossings. The prolonged presence of standing water softened the subgrade layer and weakened the bond between the asphalt surface and underlying layers, leading to raveling, stripping, and premature fatigue cracking. These drainage deficiencies were identified as one of the primary contributors to the accelerated deterioration of the pavement structure.

Figure 1. Pavement distress types observed from the direction of the Public Works and Spatial Planning Office of Palembang.

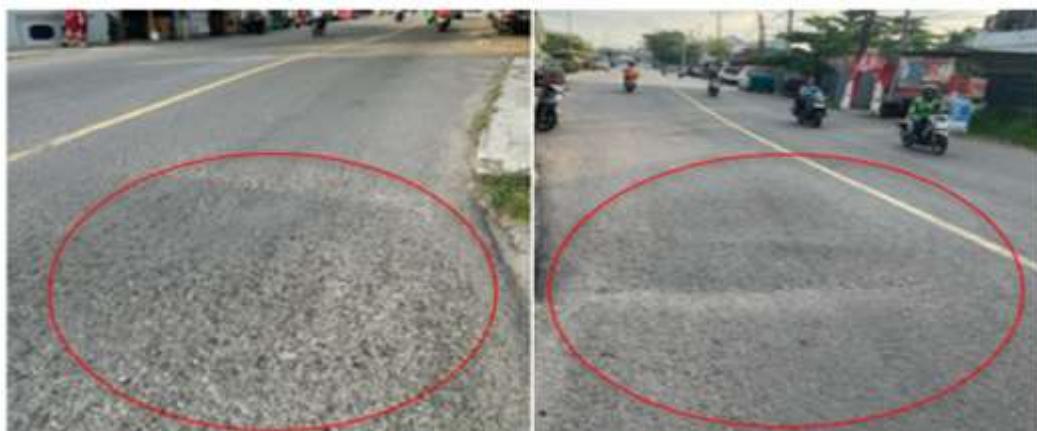
Figure 2. Pavement distress types observed from the direction of the Port Hospital of Palembang.

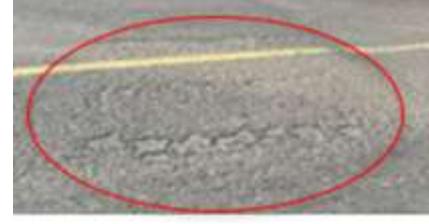
No	STA (m)	Position	Type of Distress	Photo Documentation
1	0+000 – 0+060	Left	Alligator cracking

The overlay treatment was recommended for areas exhibiting fatigue or alligator cracking, as it provided a cost-effective approach to restore structural capacity and surface smoothness without requiring complete reconstruction. The application of a new asphalt layer improved load distribution, sealed surface cracks, and reduced water infiltration into the base and subgrade layers. Compared with full-depth rehabilitation, overlays typically extended pavement service life by approximately five to ten years at about 40 to 60 percent lower cost, making them an efficient preventive measure for moderately deteriorated pavements.

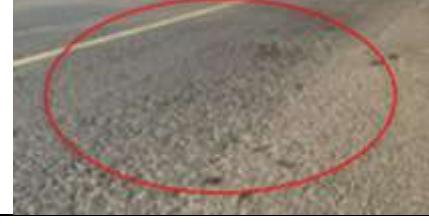
2	0+060 – 0+120	Left	Alligator cracking
